**McDONNELL 40-kW  
GIROMILL WIND SYSTEM**

**Phase II  
Fabrication and Test**

**JUNE 1980**

**ROBERT BRULLE**

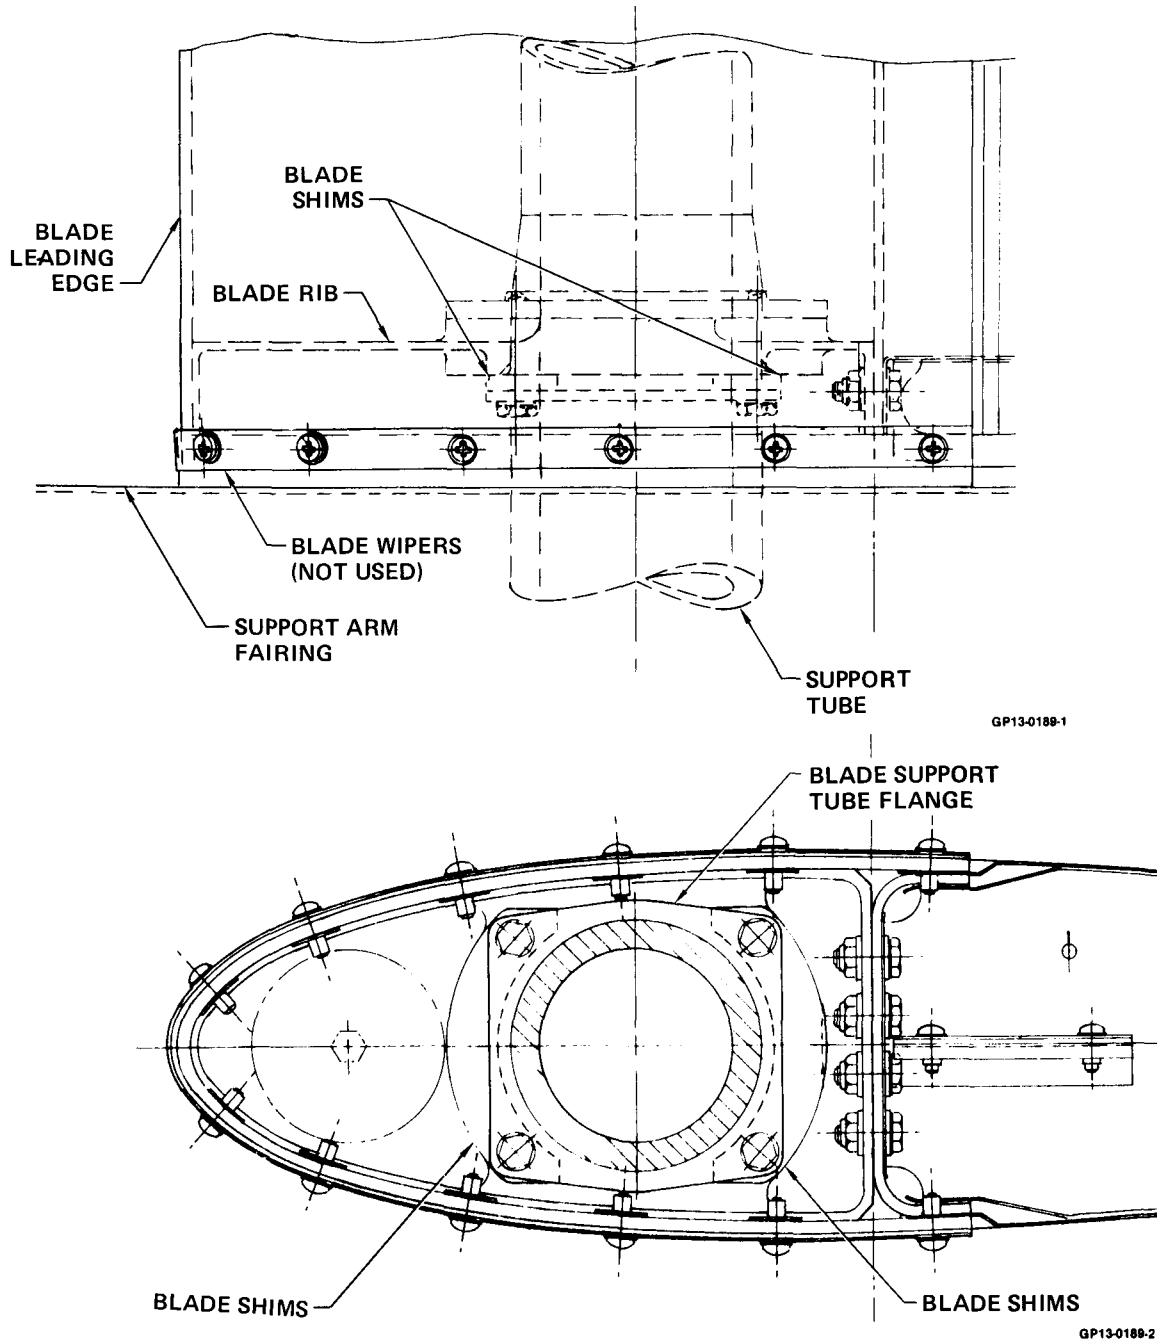
Blade Shims - When assembling the Giromill it was determined that tolerances could add up and cause the blades to rub against the support arm fairings. To increase the clearance, blade shims were made to fit between the blade support tube mounting flange and the blade rib, as shown in Figure 30. Shims having a thickness of 3/16 or 1/4 inch were used as required to provide clearance. MCAIR Drawing 71A090101 shows that change.

**FIGURE 30**  
**BLADE SHIMS FOR CLEARANCE**

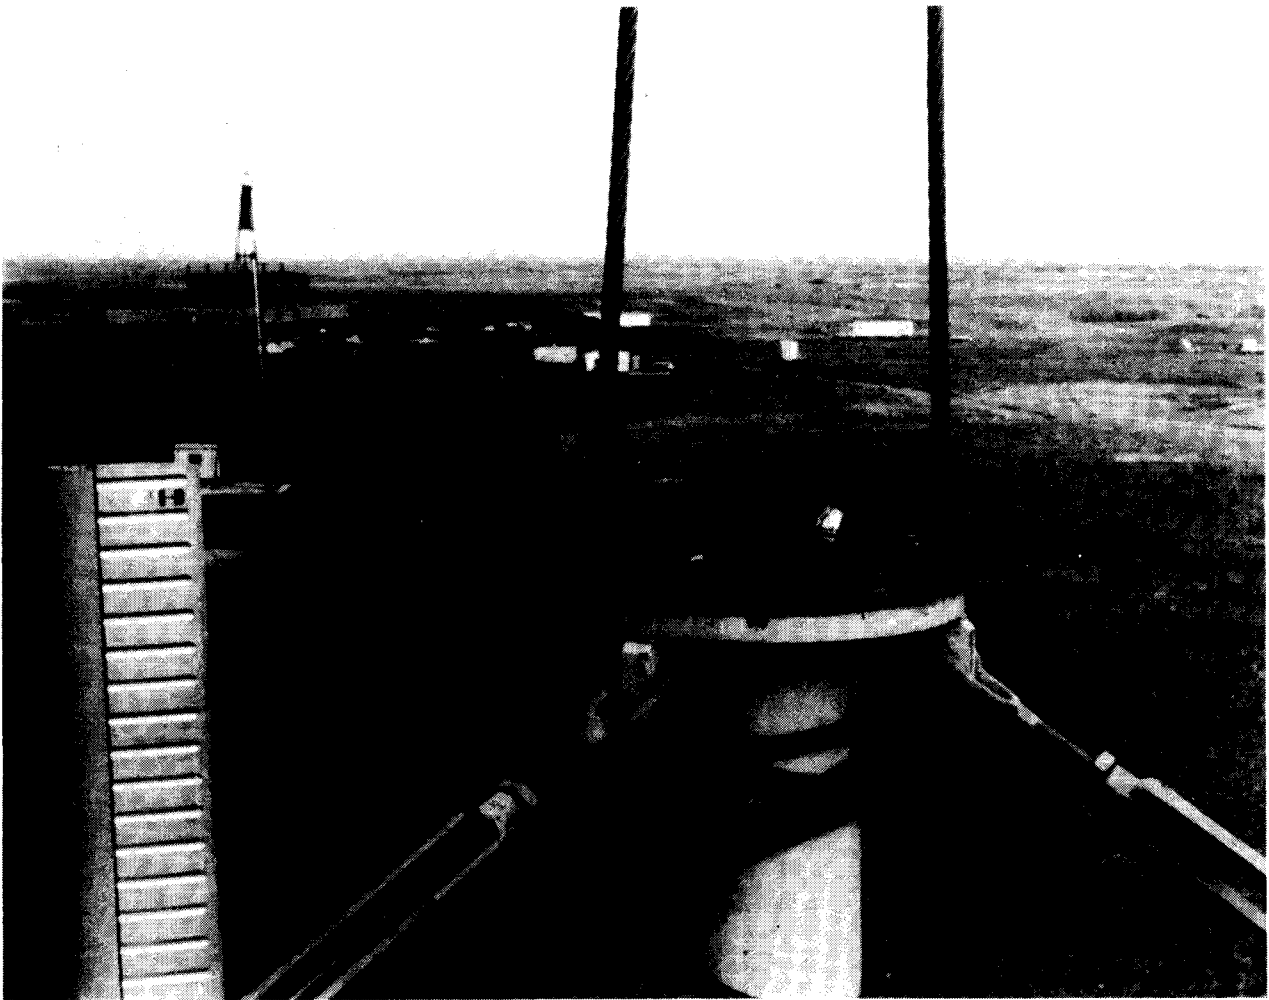
A visual inspection revealed that the nuts had pulled through the washers, allowing the bolts, nuts, and spacers to pass through the holes in the base of the pole and remain with the rotating tower as shown in Figure 39. The washers were partially extruded into the pole base holes, as shown in Figure 40, indicating that the washers failed in shear. In addition, paint was chipped along the weld line attaching the pole tube to the base plate indicating possible high oscillatory loads.

**FIGURE 39**  
**LIGHTNING POLE-TO-ROTATING TOWER INTERFACE JOINT**

The location of the pole on the ground after the accident indicated that the attach bolts failed while the Giromill was running. The wind speed at the time of failure was probably 40-45 MPH (possibly 5 MPH over cut-off speed). Since considerable margins of safety exist for the joint at this wind velocity, it is speculated that dynamic forces added to the wind drag loads on the pole to cause failure. These forces could have resulted from a soft spring constant of the joint, from a loose joint at the pole base caused by bending of the washers from previous high wind loads, from spacers too long to allow proper seating of nuts, or from insufficient torque on the nuts.

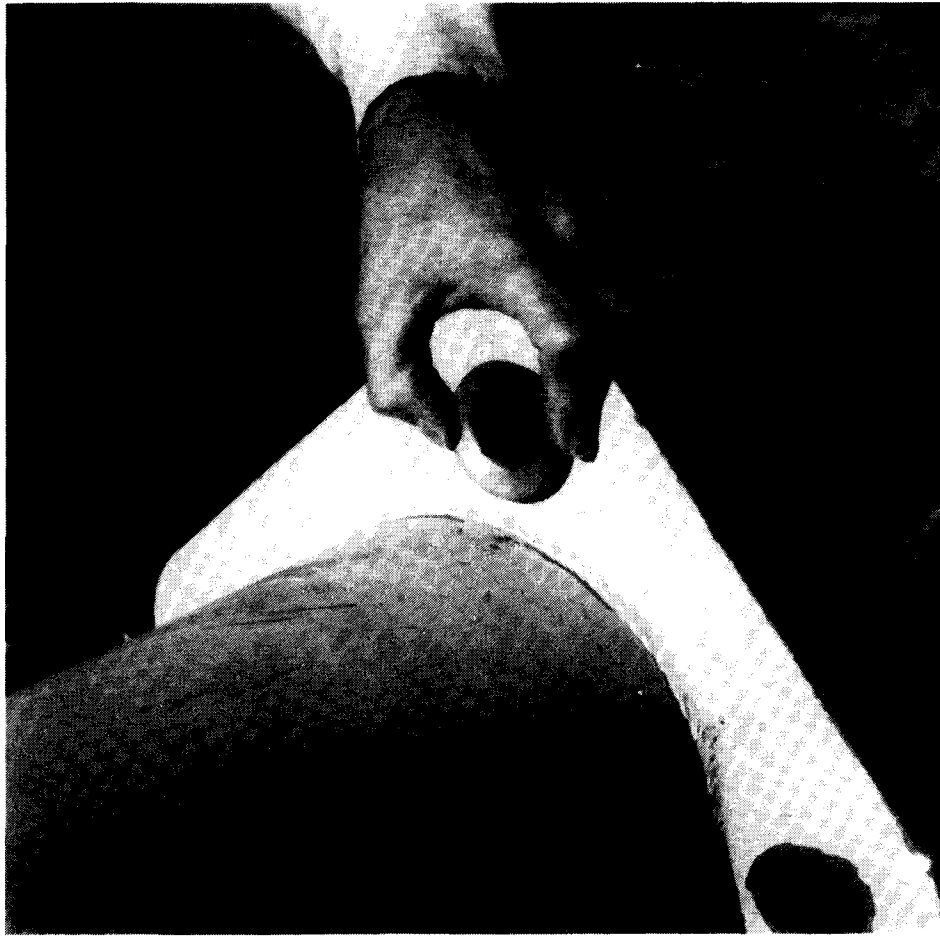
**FIGURE 40  
WASHER PARTIALLY EXTRUDED INTO HOLE**

The location of the load is based on measurements of markings on the failed washer. As the washer deflects under increasing load, this point of load application would move towards the bolt centerline, reducing the eccentricity for bending and approaching a pure shear loading. Bending stresses calculated in the manner described will therefore be higher than the actual stresses. (The actual failure mode of the washer was in shear, as shown in Figure 40.)

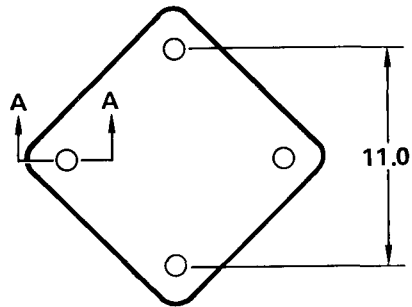
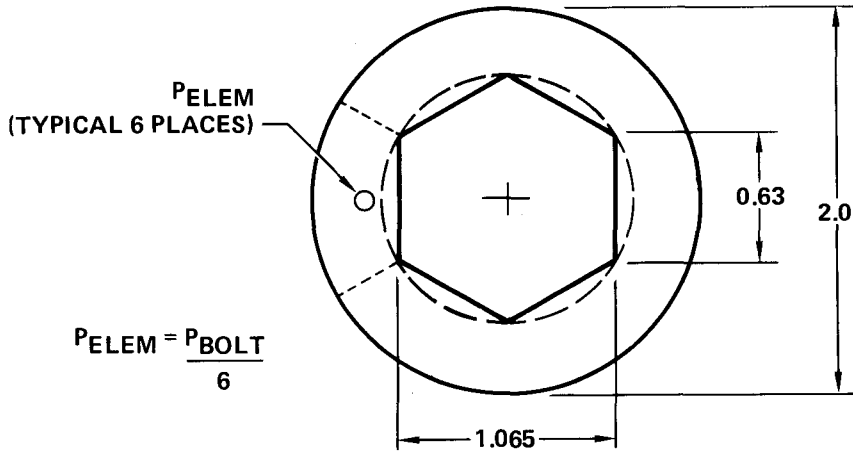
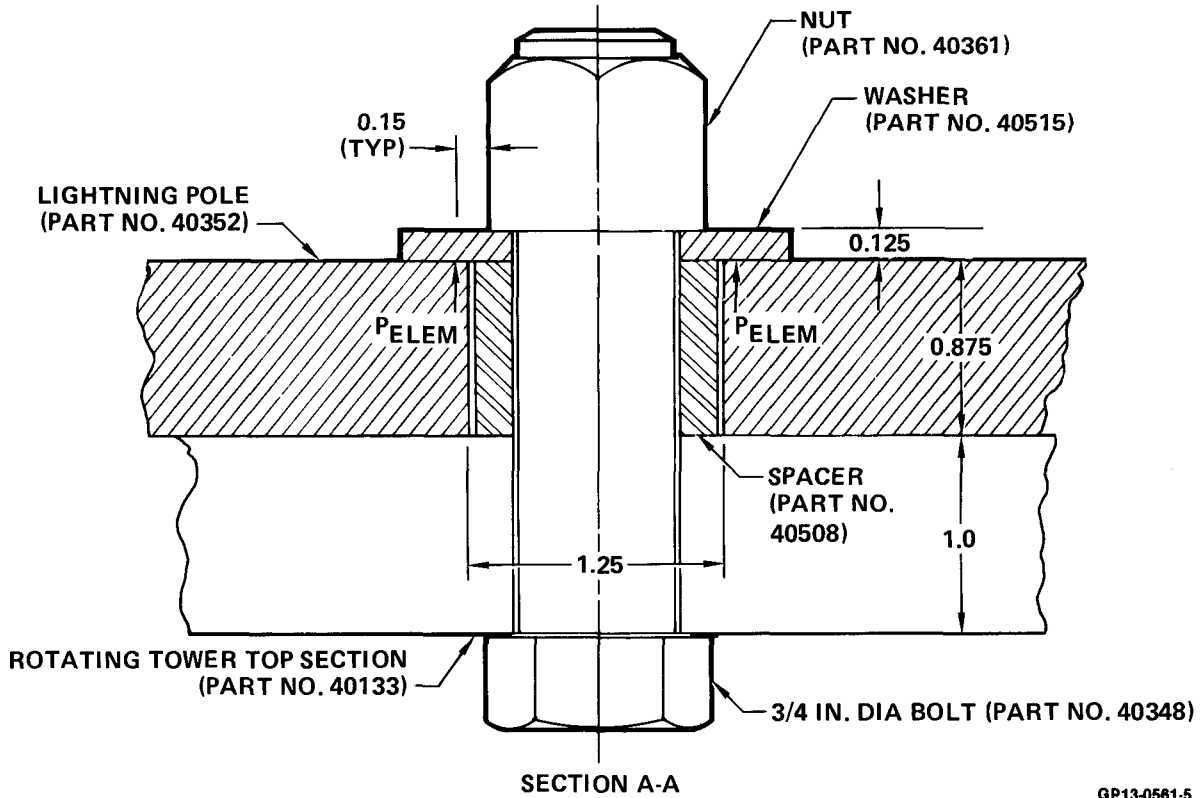
through an attach bolt is shown in Figure 41. Bolts were assumed to react to the pole root bending moment as a couple between bolts at diagonally opposite corners. Figure 42 lists, for each incremental wind velocity, the total drag load, root bending moment on the pole, and the maximum individual bolt load.

Bending and shear stresses on the washer are plotted versus wind velocity in Figure 43. Stresses were calculated assuming that the washer was divided into six equal segments, each segment being fixed at its intersection with the edge of the nut face. Thickness of the washer used in the analysis was scaled from an actual part. Bending of each segment was caused by an upward force on the washer applied by the pole base as shown in Figure 41.

FIGURE 41  
LIGHTNING POLE-TO-ROTATING TOWER INTERFACE GEOMETRY

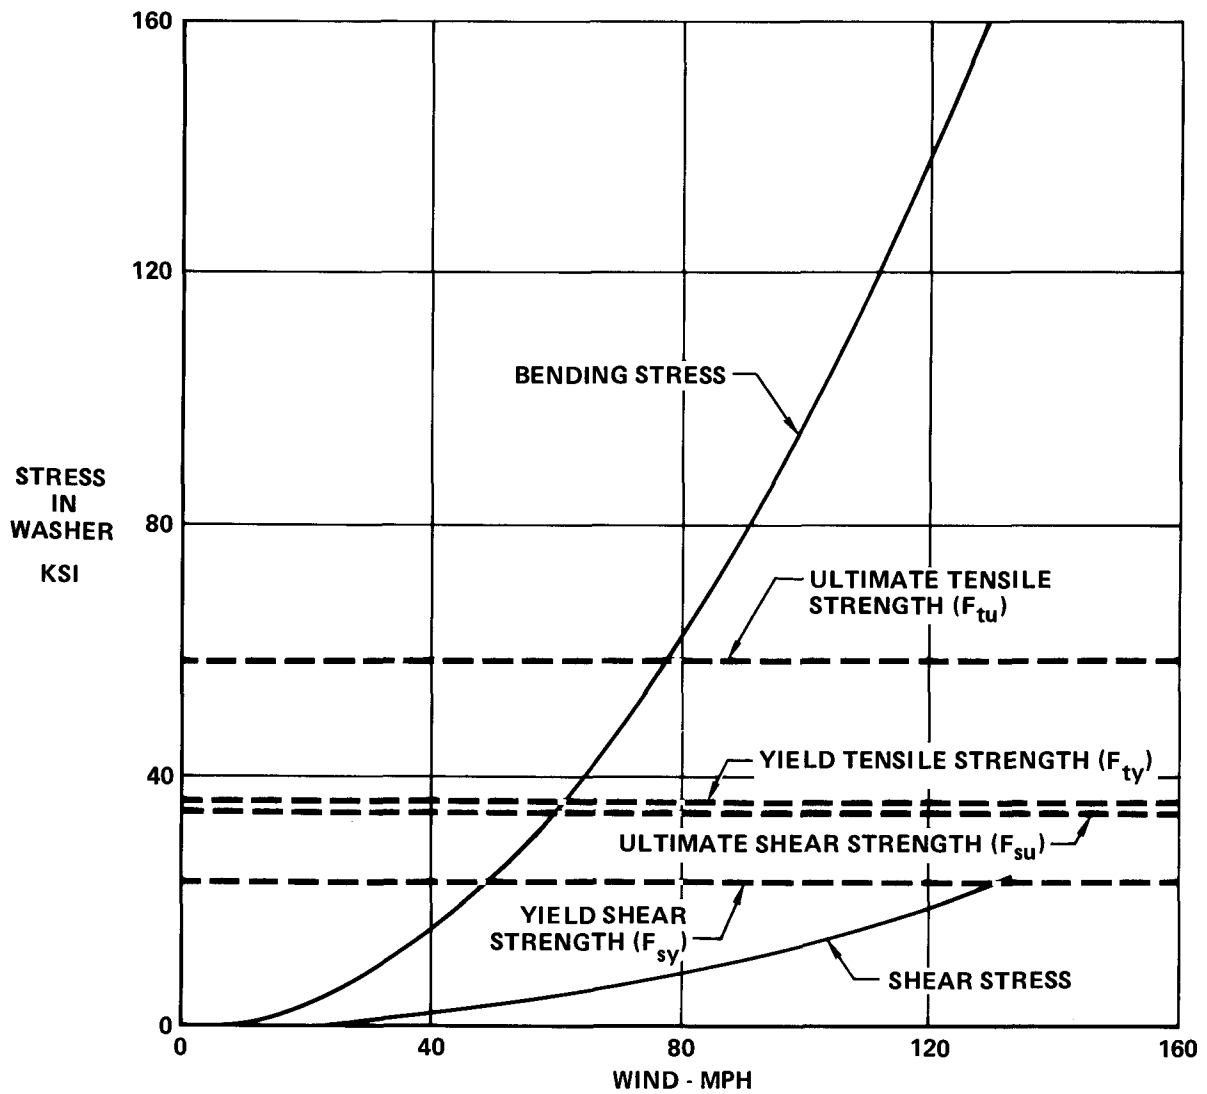
At a wind velocity of 40 mph, the Giromill is programmed to shut down. At this wind velocity, there is ample margin of safety on yield strength, as shown in Figure 42, for both shear and bending. A positive margin of safety exists on yield strengths for bending up to a wind velocity of 60 MPH. A positive margin of safety exists on yield strength for shear stresses up to a wind velocity of 130 MPH.

**FIGURE 43**  
**WASHER BENDING AND SHEAR STRESS**

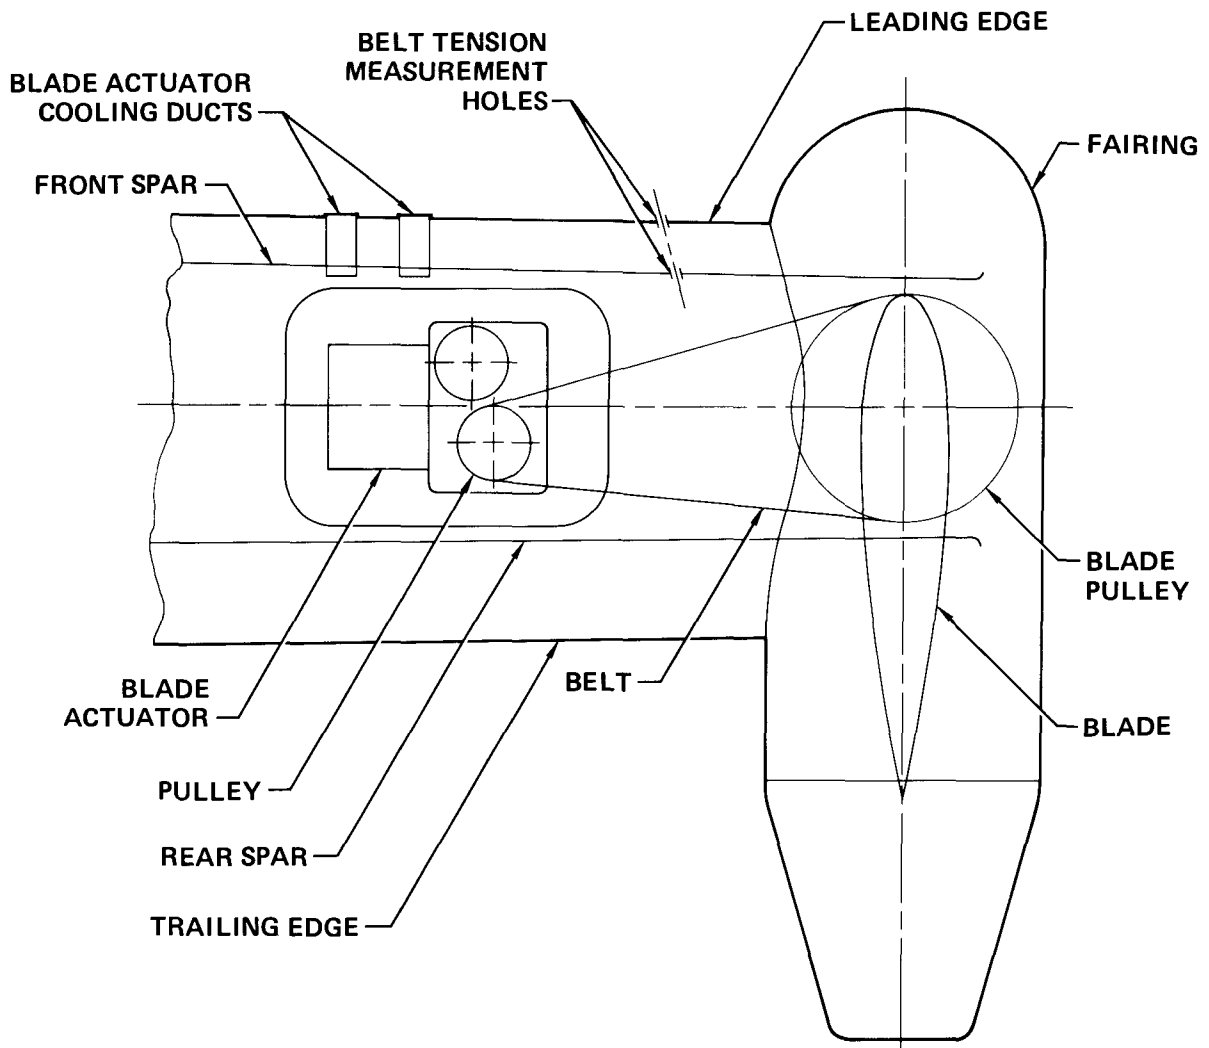
Actuator Pulley Loss - The actuators are connected to the blades by a toothed belt and pulley system. When the Giromill is running, the blade is continually being cycled back and forth by the actuator. This cyclic motion has resulted in the actuator pulleys coming loose and falling off. These pulleys are held on by a taper lock and keyway. The taper lock specification requires torquing the set screws to 175 in-lb while tapping the taper lock. To obtain the torque value is difficult, since the actuator will turn while the screws are being tightened. A strap wrench, that fits around the pulley, was used to hold the actuator while tightening the set screws.

**FIGURE 44**  
**BLADE ACTUATOR BELT TENSION MEASURING ACCESS HOLE**

The belt specification indicates that when the belt is first installed it will stretch somewhat, and should be retightened after a few days. This should become a standard operating procedure.

To enable measurement of belt tension a belt access hole was drilled in the support arm, as shown in Figure 44. This hole is located near the belt mid span, and by inserting a 1/4 inch rod through the hole, belt tension and deflection can be measured using a belt tension tester such as is shown on Page 30-55, Reference 3. The force and deflection as measured by the tester should be 10 lbs for 0.44 inches deflection. This should give 500 lb tension in the belt.
